GILBERT ASSOCIATES INC READING PA
NATIONAL DAM SAFETY PROGRAM. CEDAR GROVE WEST, NORTH, AND SOUTH--ETC(U)
JUL 78 R J WAHANIK

**CEDAR GROVE WEST,
NORTH, AND SOUTH DAMS
PHASE I INSPECTION REPORT
NATIONAL DAM SAFETY PROGRAM**

NJ 00392

JULY 1978

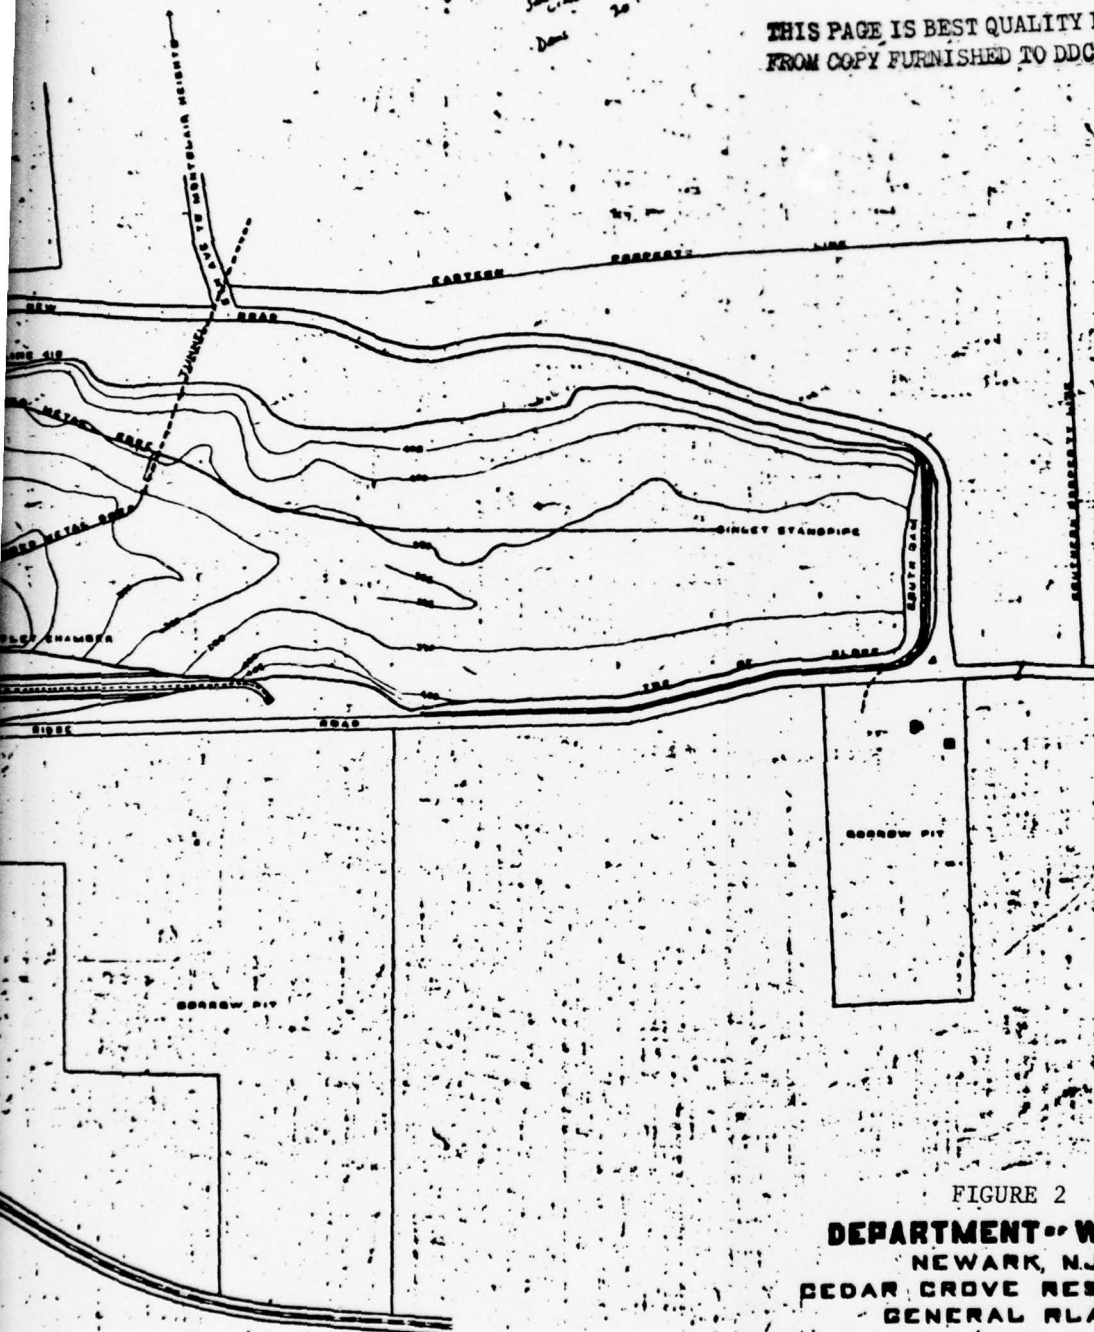
FIGURE 2
 DEPARTMENT OF WATER
 NEWARK, N.J.
 CEDAR GROVE RESERVOIR
 GENERAL PLAN

Borrow: Borrow sources are shown on Figure 2.

A few sets of record drawings showing cross-sections, profiles, and plans are available at the Newark Division of Water Supply's Office, Little Falls, N.J. No other information was available for use in this Phase I inspection. Cross-sections through the dams are shown in Figures 2, 3 and 4.
